How to get it right the first time...

FITTING INSTRUCTIONS: INSTALLING YOUR NEW EXEDY CLUTCH

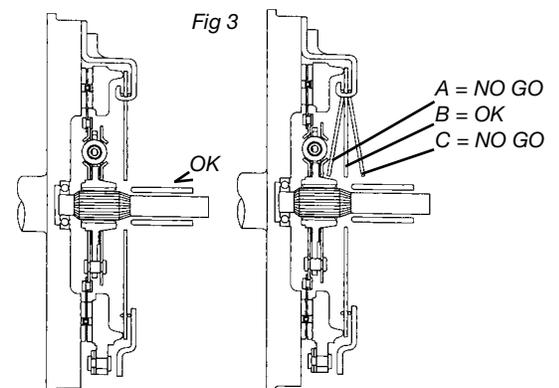
3. **Flywheel must be replaced or machined as shown below (Fig 2. max 0.03 in.) or warranty will be void** and check spigot bearing or the pilot bush and replace if necessary. Please note pilot bush noises are more apparent when the engine and transmission systems are cold (i.e. in the mornings).

7. When the pressure plate has been torqued down securely to the flywheel, ensure that the diaphragm tips (in the case of a lever type cover assembly, the release lever tips) are in a parallel or slightly upward position (see Fig 3) and do not go over center of the parallel position.

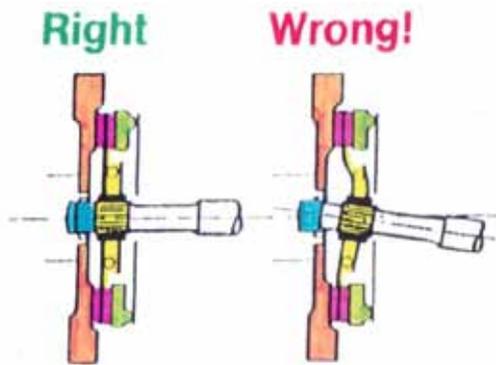
Hanging the Gearbox

8. Refit gear box, taking care not to bend the clutch disc. Never hang the gear box off the clutch disc or use any force to align gear box shaft.
9. Check all bell housing dowels are in correct position and tighten bell housing bolts. Ensure there is no dirt or foreign material between the mating surfaces of the engine and the bell housing.
